# *Environmental Support Network, Inc.*

RE: The Former Stewart Brothers Paint  
Mill Room Building  
Alliance, Ohio

On November 5, 2012, Environmental Support Network, Inc. acquired samples of construction materials from the former Stewart Brothers Paint Property's Mill Room Building located at 1010 North Union Avenue in, Alliance Ohio 44601. The samples were taken of the construction materials resident in the building. Random sampling was conducted pursuant to 40 CFR 763.86. The construction materials sampled are those materials that might become friable during the forces of the planned demolition activity. The purpose of conducting this sampling was to acquire pre-demolition samples of construction materials to satisfy the National Emissions Standards for Hazardous Air Pollutants (NESHAP's) regulations as codified in 40 CFR Part 61.

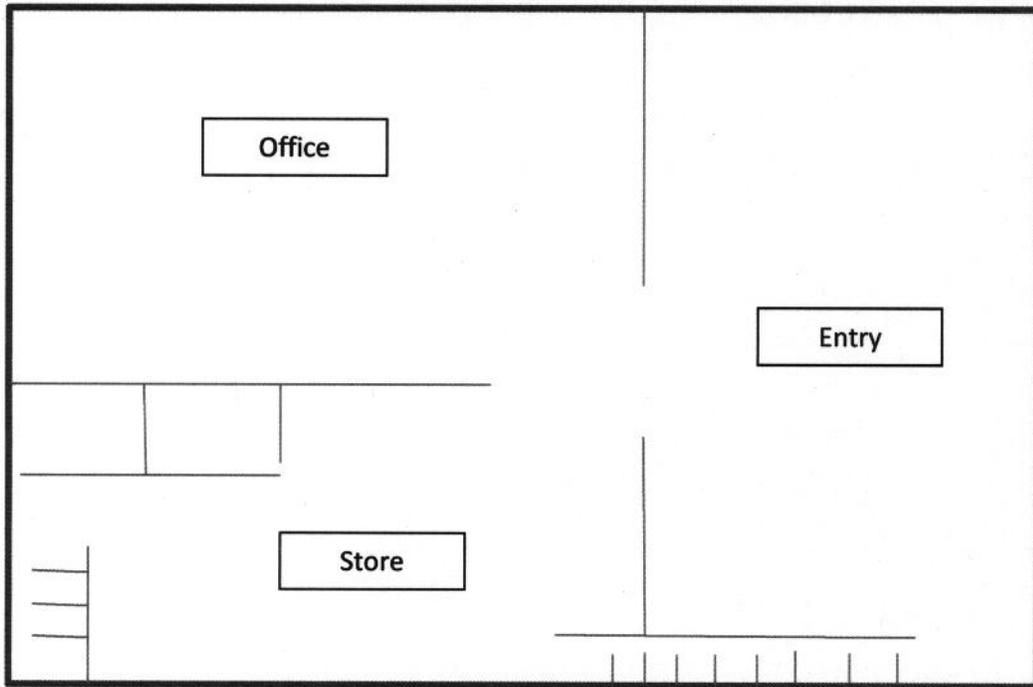
Upper Floor

Two-(2) materials tested have 4% asbestos content. These are the floor tile in the office of the upper level of the Mill Building. These materials are considered a regulated asbestos-containing material. The floor tile is in damaged condition. The area of the floor tile measures 10' x 20' for a total of 200 square feet of floor area. Attached is a map showing the areas where the aforementioned materials are present.
