Environmental Support Network, Inc.

November 14, 2012

RE: The Former Volcanic Heater Building
Alliance, Ohio

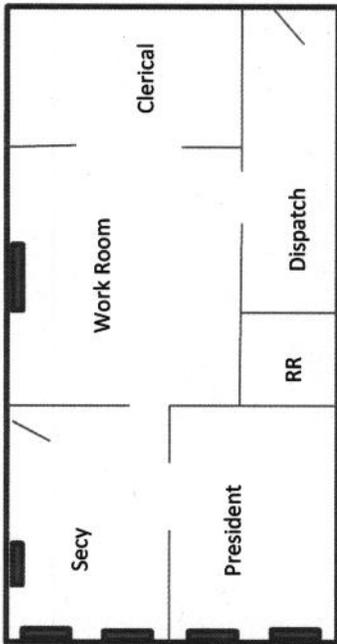
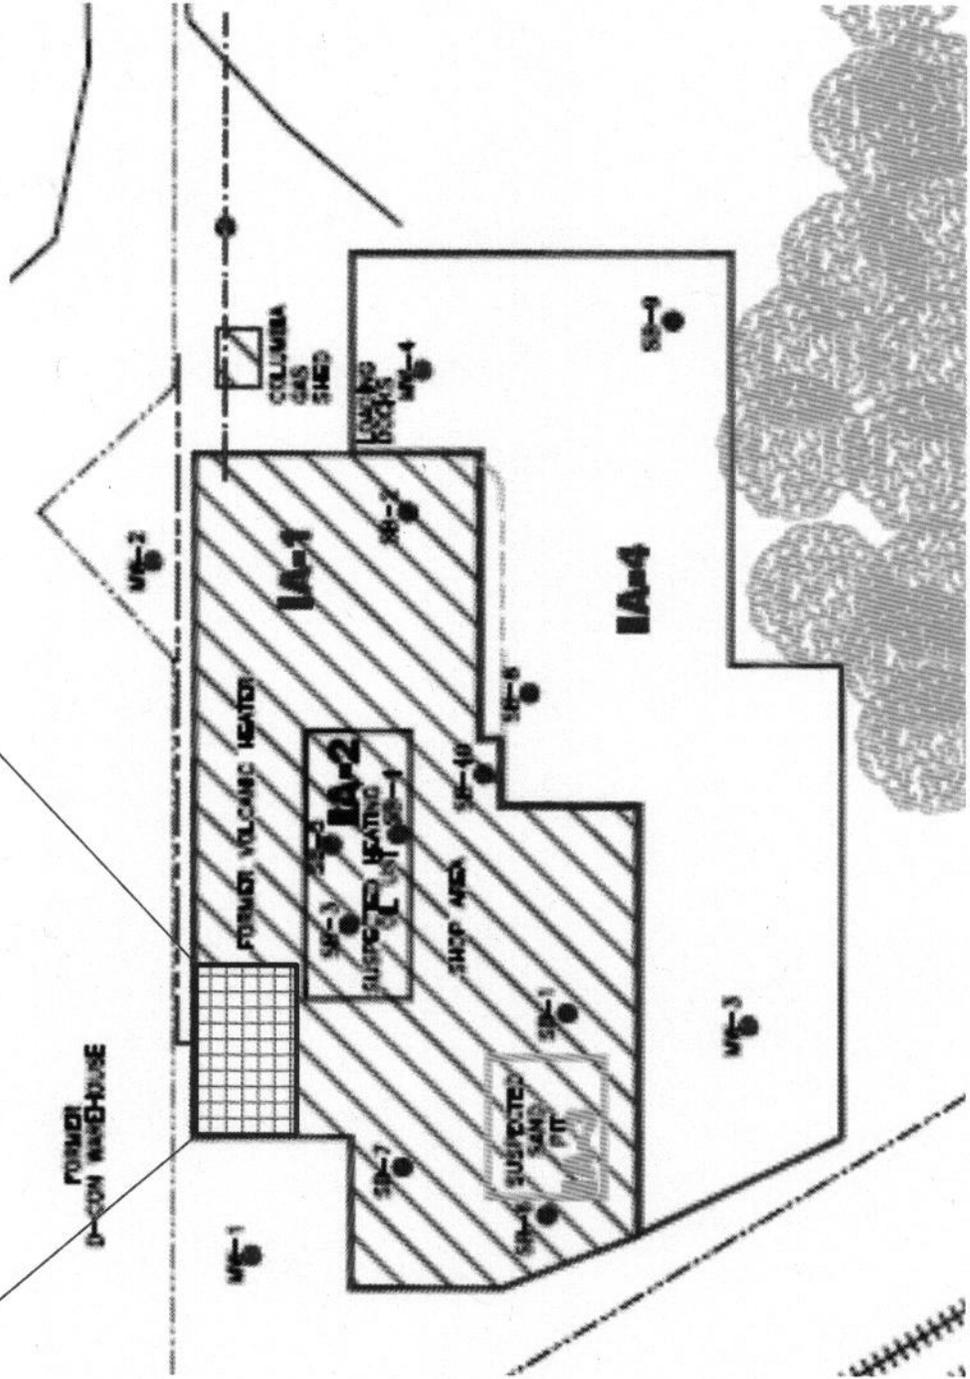
Site Sketch

Based on the above, the window glazing materials in the office of the building are regulated asbestos containing materials. At the current time, these materials are in good condition. There are approximately 55 linear feet of the window glazing materials present. Attached is a sketch showing the areas where the ACM is present.

Office Area: The Volcanic Heater Building

Measurements: 16' x 20' total square feet

Windows - 6 (office area only)
