# *Environmental Support Network, Inc.*

RE: The Former Stewart Brothers Paint  
Mill Room Building  
Alliance, Ohio

On November 5, 2012, Environmental Support Network, Inc. acquired samples of construction materials from the former Stewart Brothers Paint Property's Mill Room Building located at 1010 North Union Avenue in, Alliance Ohio 44601. The samples were taken of the construction materials resident in the building. Random sampling was conducted pursuant to 40 CFR 763.86. The construction materials sampled are those materials that might become friable during the forces of the planned demolition activity. The purpose of conducting this sampling was to acquire pre-demolition samples of construction materials to satisfy the National Emissions Standards for Hazardous Air Pollutants (NESHAP's) regulations as codified in 40 CFR Part 61.

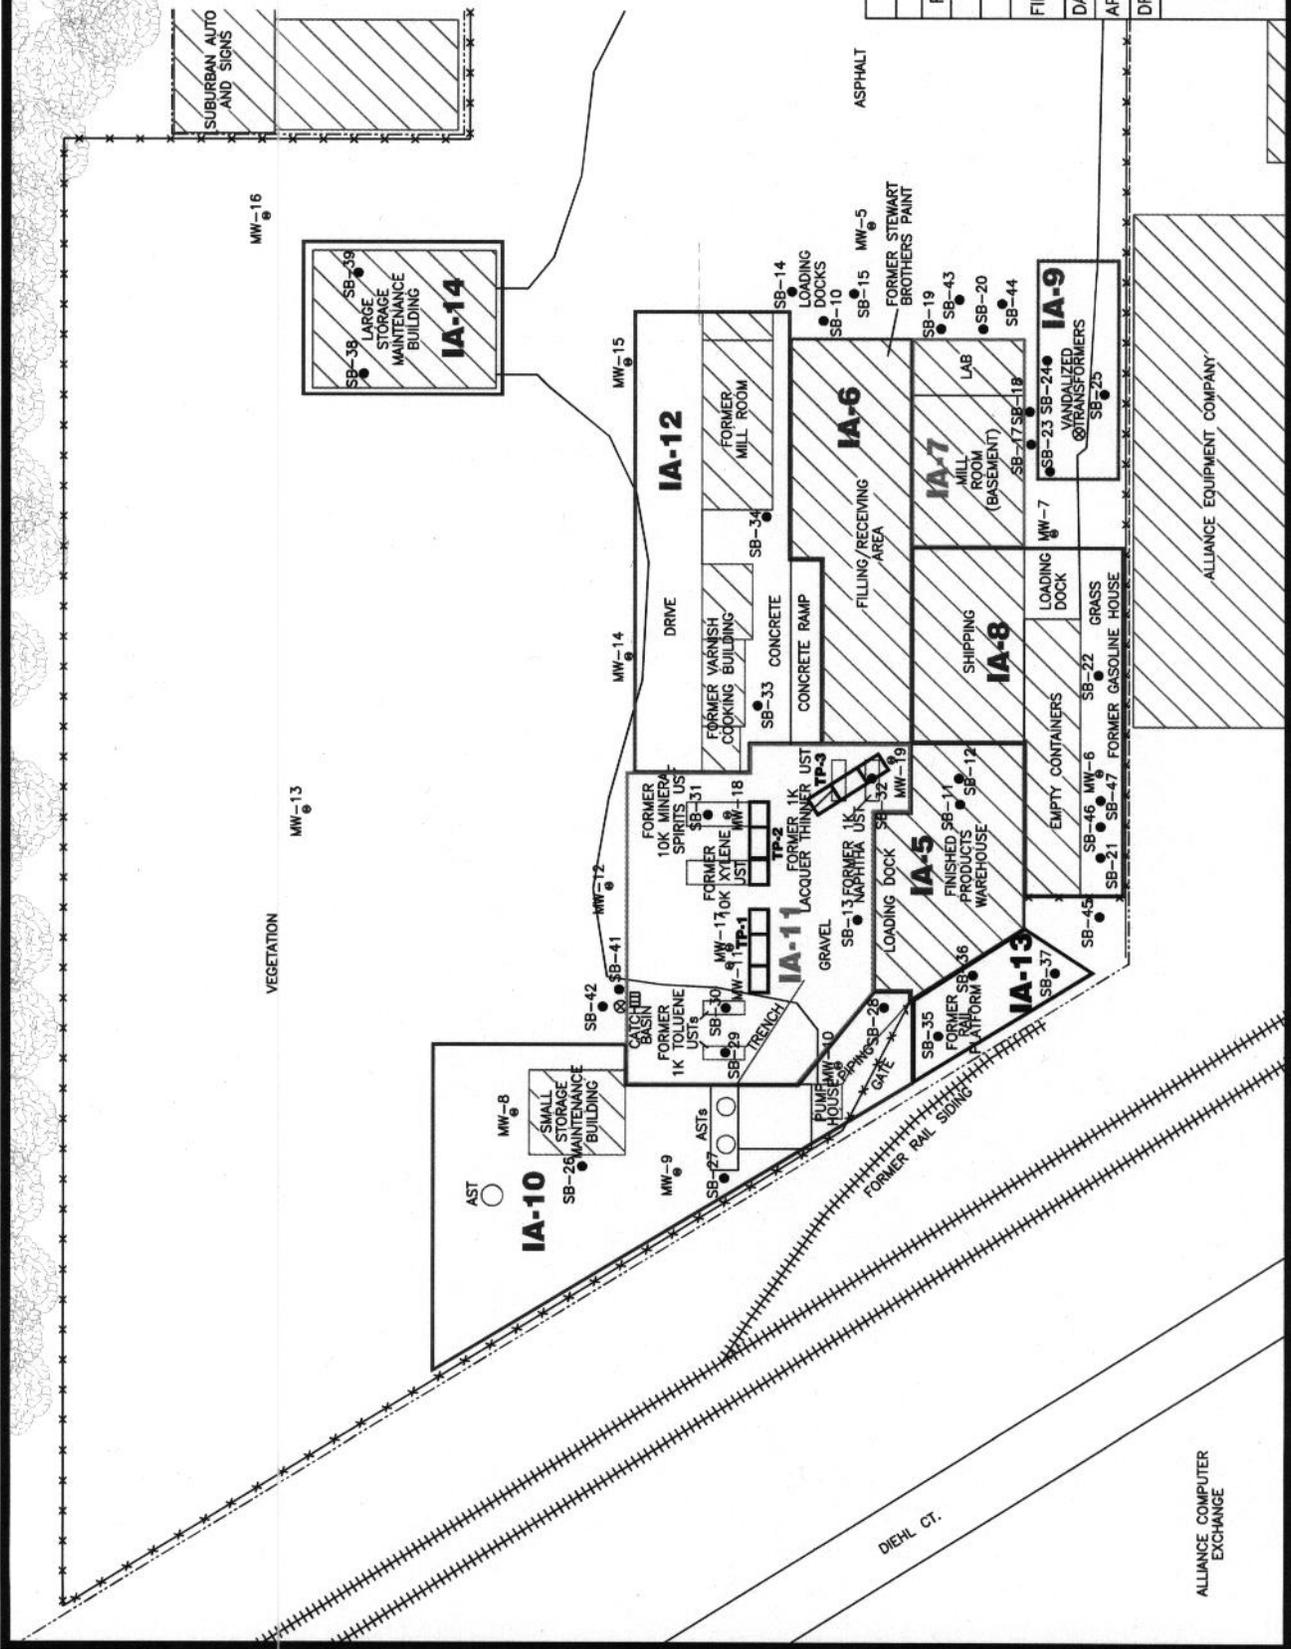
FIGURE 4b:

Two-(2) materials tested have 4% asbestos content. These are the floor tile in the office of the upper level of the Mill Building. These materials are considered a regulated asbestos-containing material. The floor tile is in damaged condition. The area of the floor tile measures 10' x 20' for a total of 200 square feet of floor area. Attached is a map showing the areas where the aforementioned materials are present.

SAMPLING MAP
112039
FORMER STEWART BROTHERS PAINT
1010 NORTH UNION AVENUE
ALLIANCE, OHIO 44601
FILE NAME= 112039-STEWARD-PAINT-
SITE-2-IA-2
DATE: NOVEMBER 9, 2012
APPRX. SCALE: 1"=40'
DRAWN BY: J.P.GREEN
